PROBLEM SOLVED™ PAPER

SOLUTION: Martin® QC1™ Cleaner HD

INDUSTRY: Cement

LOCATION: GCC of America Dacotah Plant Rapid City, South Dakota

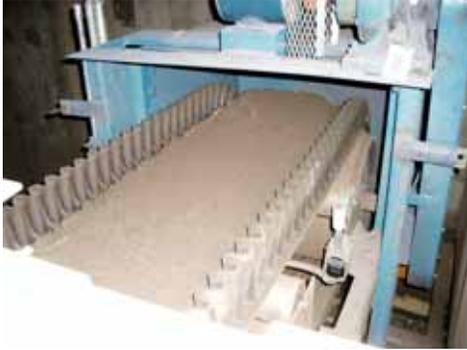
The plant's weigh feeders suffered carryback as a result of an inability to effectively clean the sidewall belts.

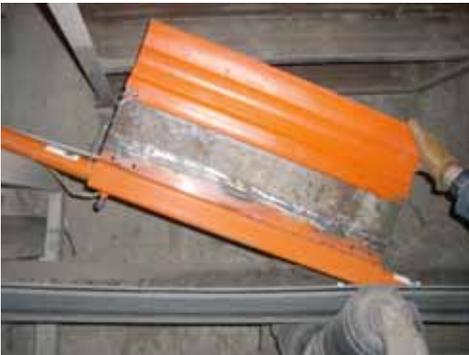
The Martin® QC1™ Cleaner HD was installed on a modified mainframe to provide effective cleaning without interference from the sidewalls of the belt.

To remove the residual material from the sidewall belts on the three most problematic of the weigh feeders, Martin Engineering proposed a modified version of the Martin® QC1™ Cleaner HD. This special cleaner incorporated an extended mounting spine to increase the distance from the mainframe to the belt. The modification raises the cleaning edge 4.64 inches (118 mm) while centering the blade between the sidewalls. This allows the corrugated sides to pass without problems.

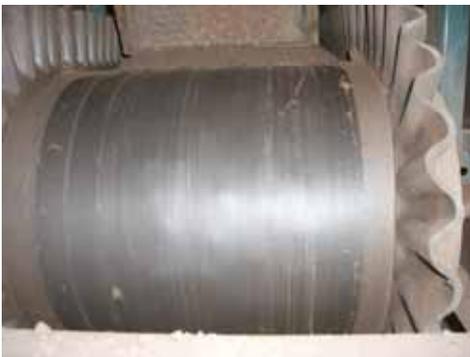
Following installation of the Martin® QC1™ Cleaner HD, the corrugated sidewall belts on the weigh feeders were much cleaner.

Belt cleaning was noticeably improved, and the accumulation of material under the three weigh feeders was significantly reduced. Plant officials note that the plant had reduced clean-up chores from roughly a wheelbarrow full of material every three days, to about one-fourth of a wheelbarrow in a two-week period. Plant officials noted these belts show significant wear, including small pockets across their carrying surface. Consequently, the belt cleaners are unable to totally clean these indentations; the plant is confident that new (smoother) belts would virtually eliminate the problem. Martin Engineering representatives were congratulated by several employees of the Dacotah plant of GCC of America, Inc. for solving this difficult and long-standing problem.
